Draft Cap Inspection Report for the Former Pacific Electric Motors Facility, 1009 66th Avenue, Oakland, California

1009 66TH AVENUE
OAKLAND, CALIFORNIA
CAP INSPECTION

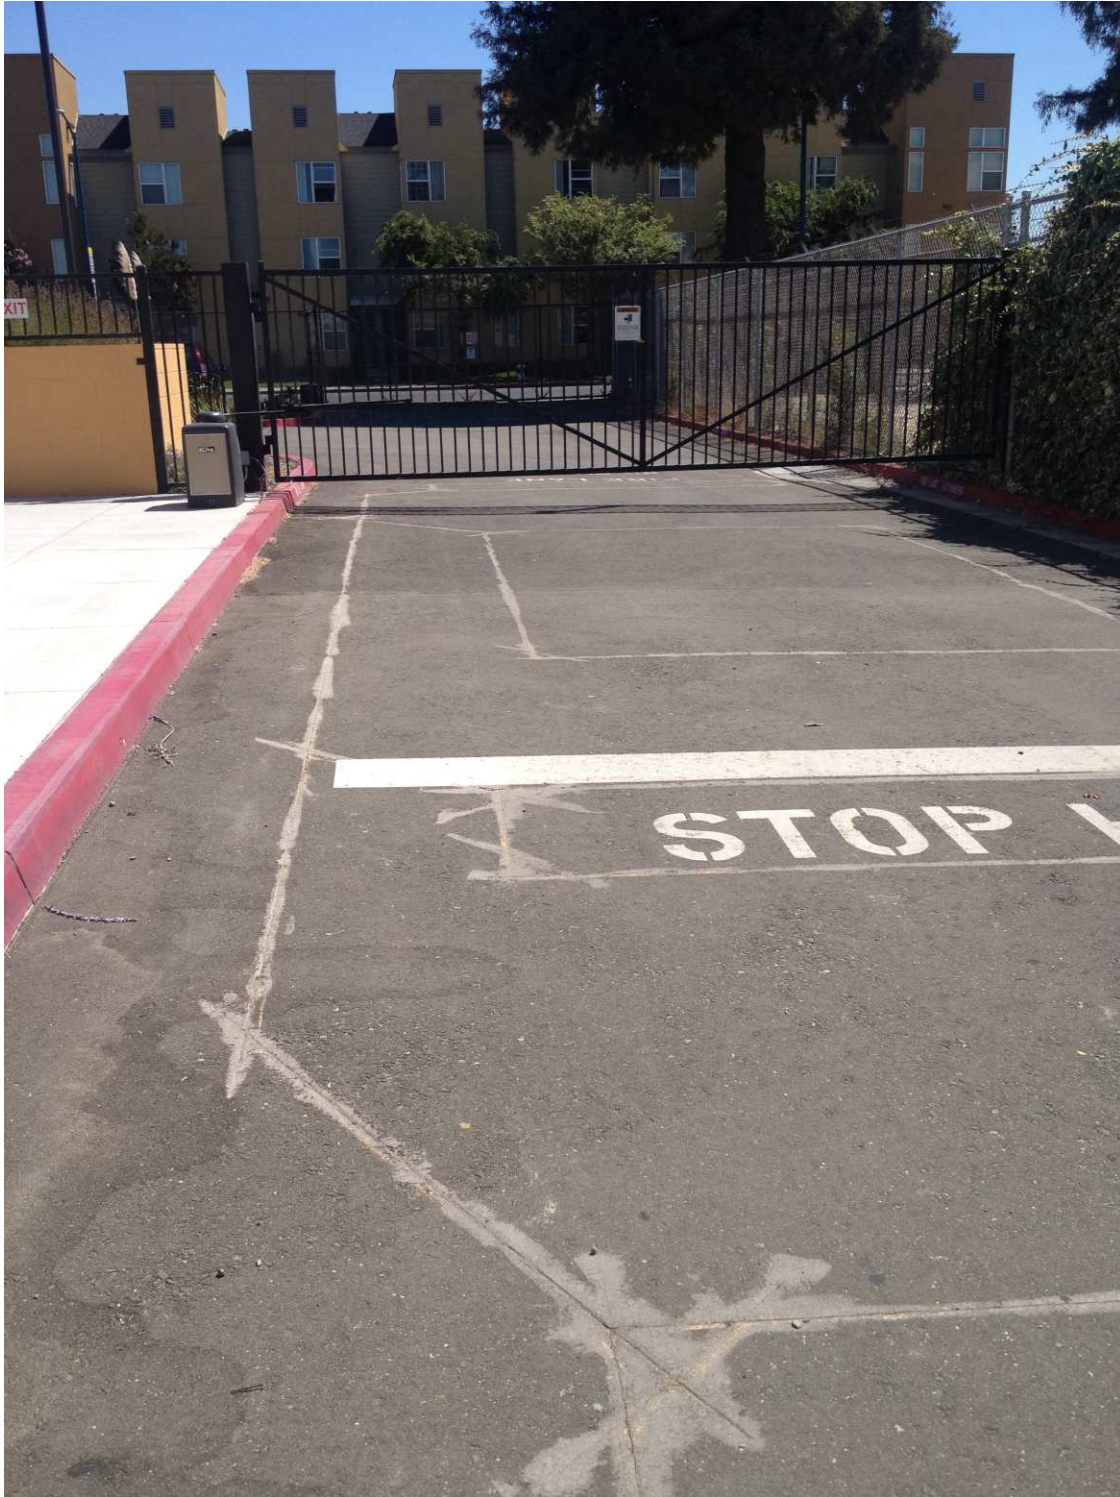
FIGURE
1

Vehicle Traffic Area Looking Southwest Towards 66th Avenue

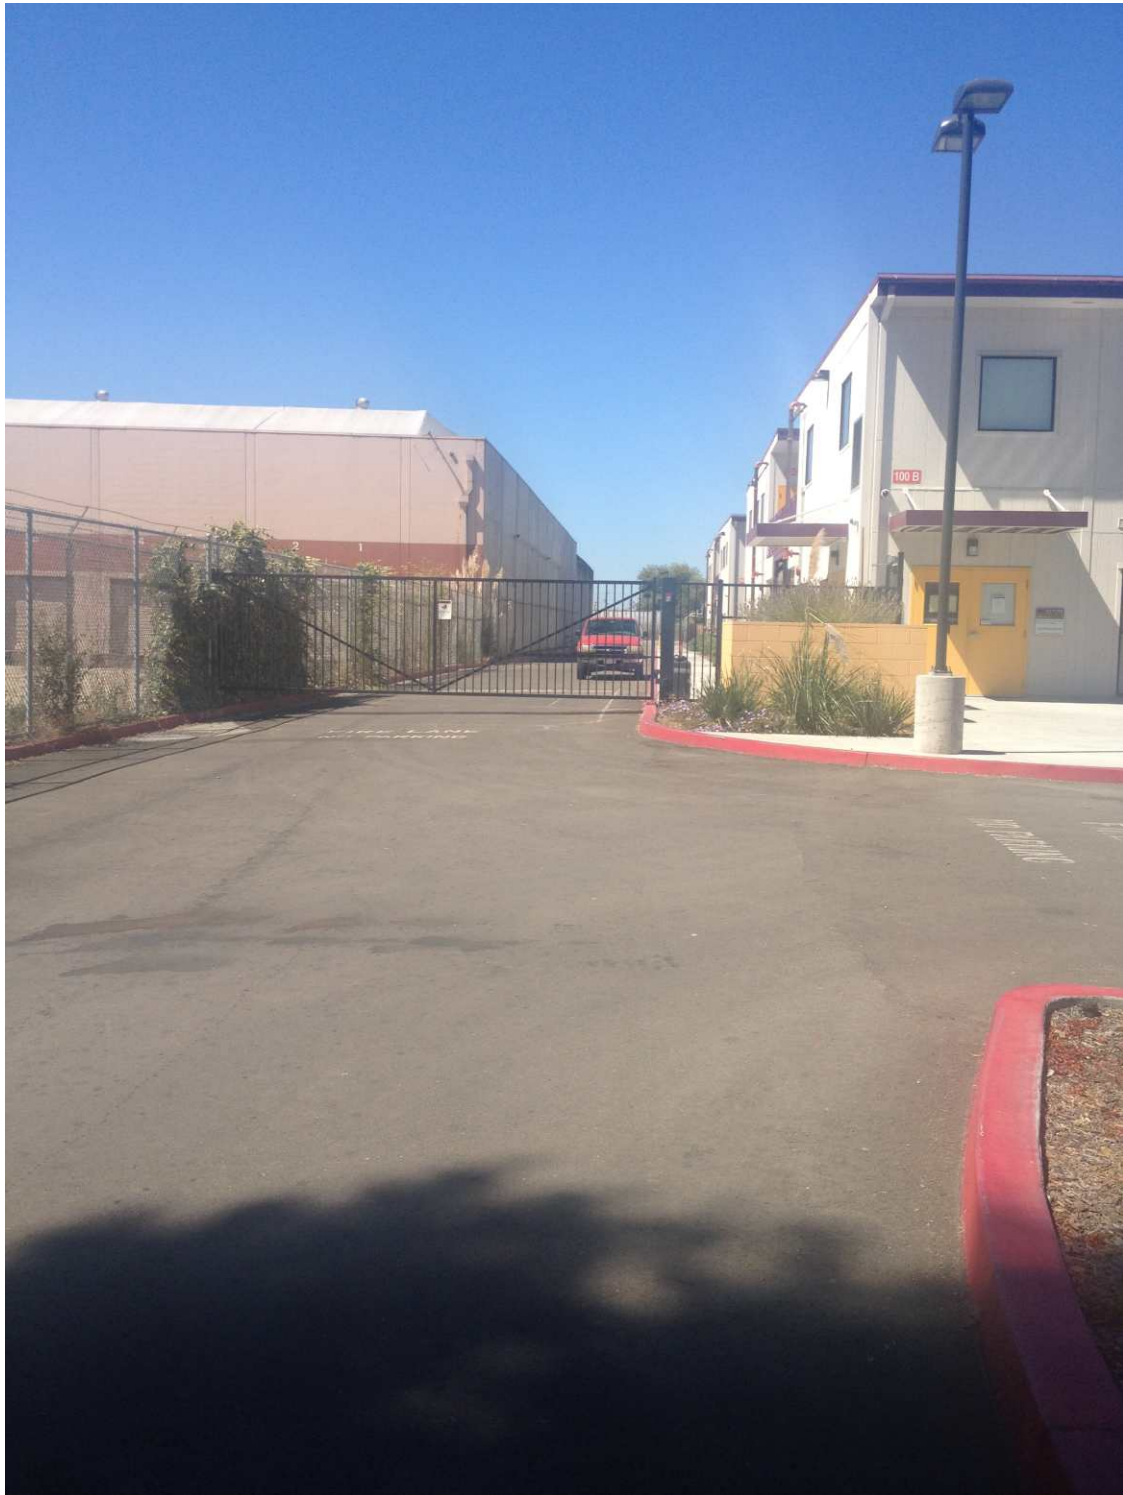
FIGURE
2

Vehicle Traffic Area Looking Towards the School

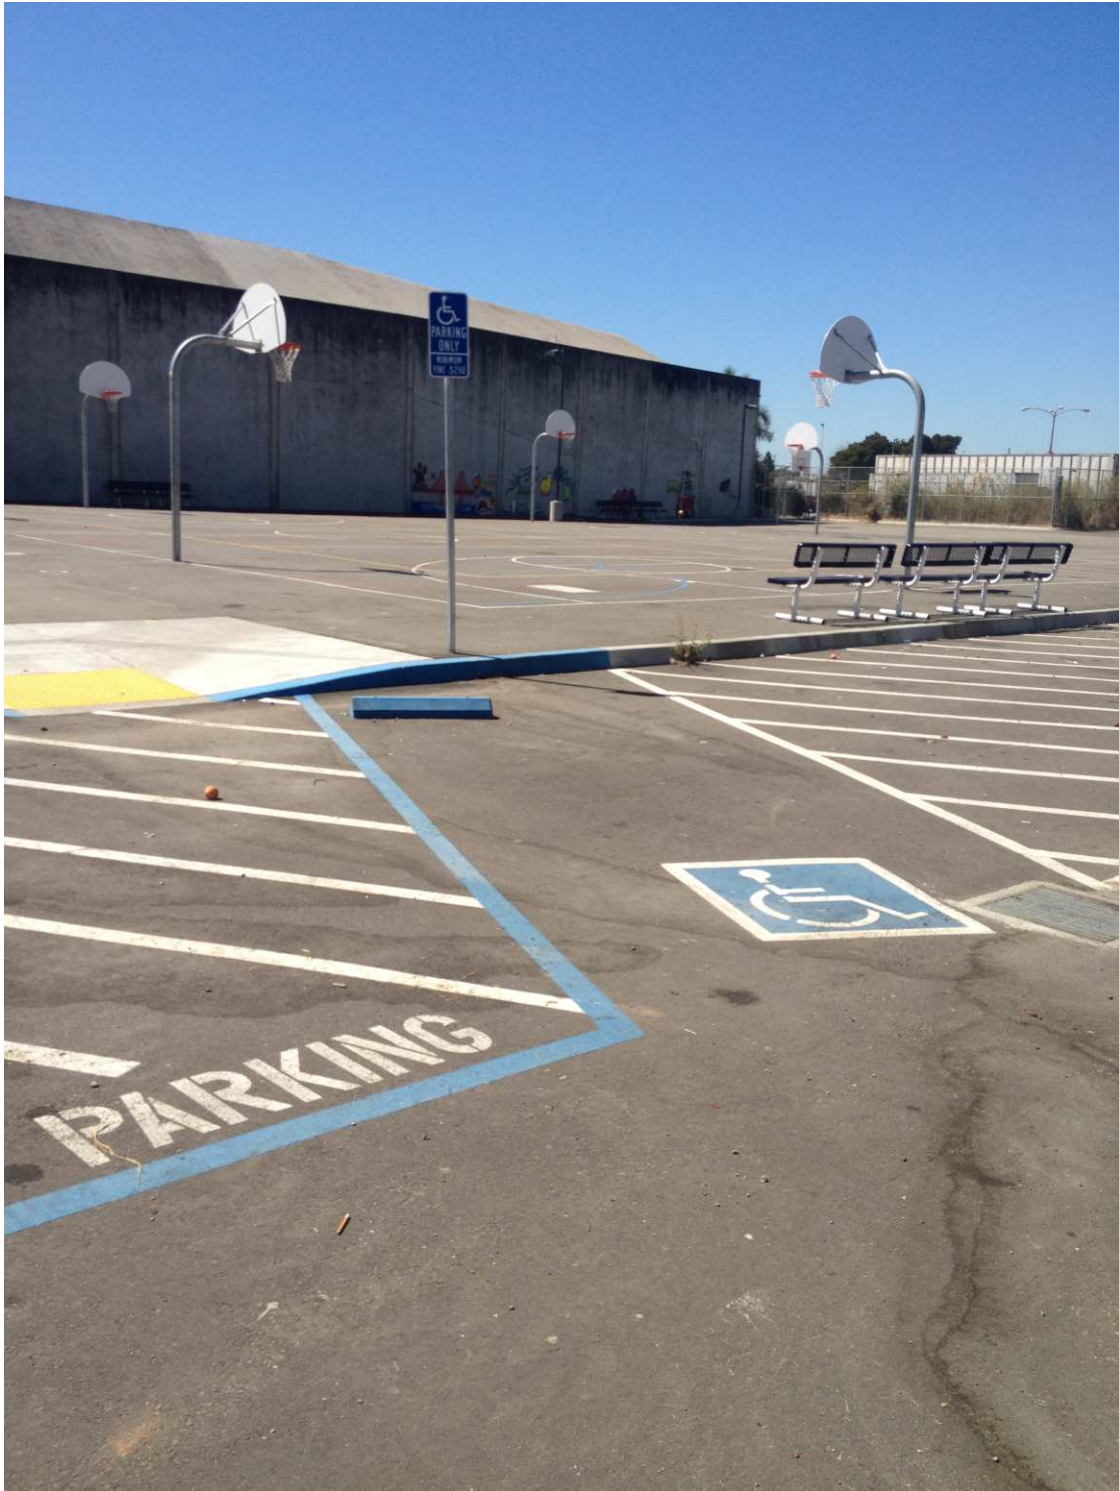
FIGURE
3

Vehicle Traffic Area looking north

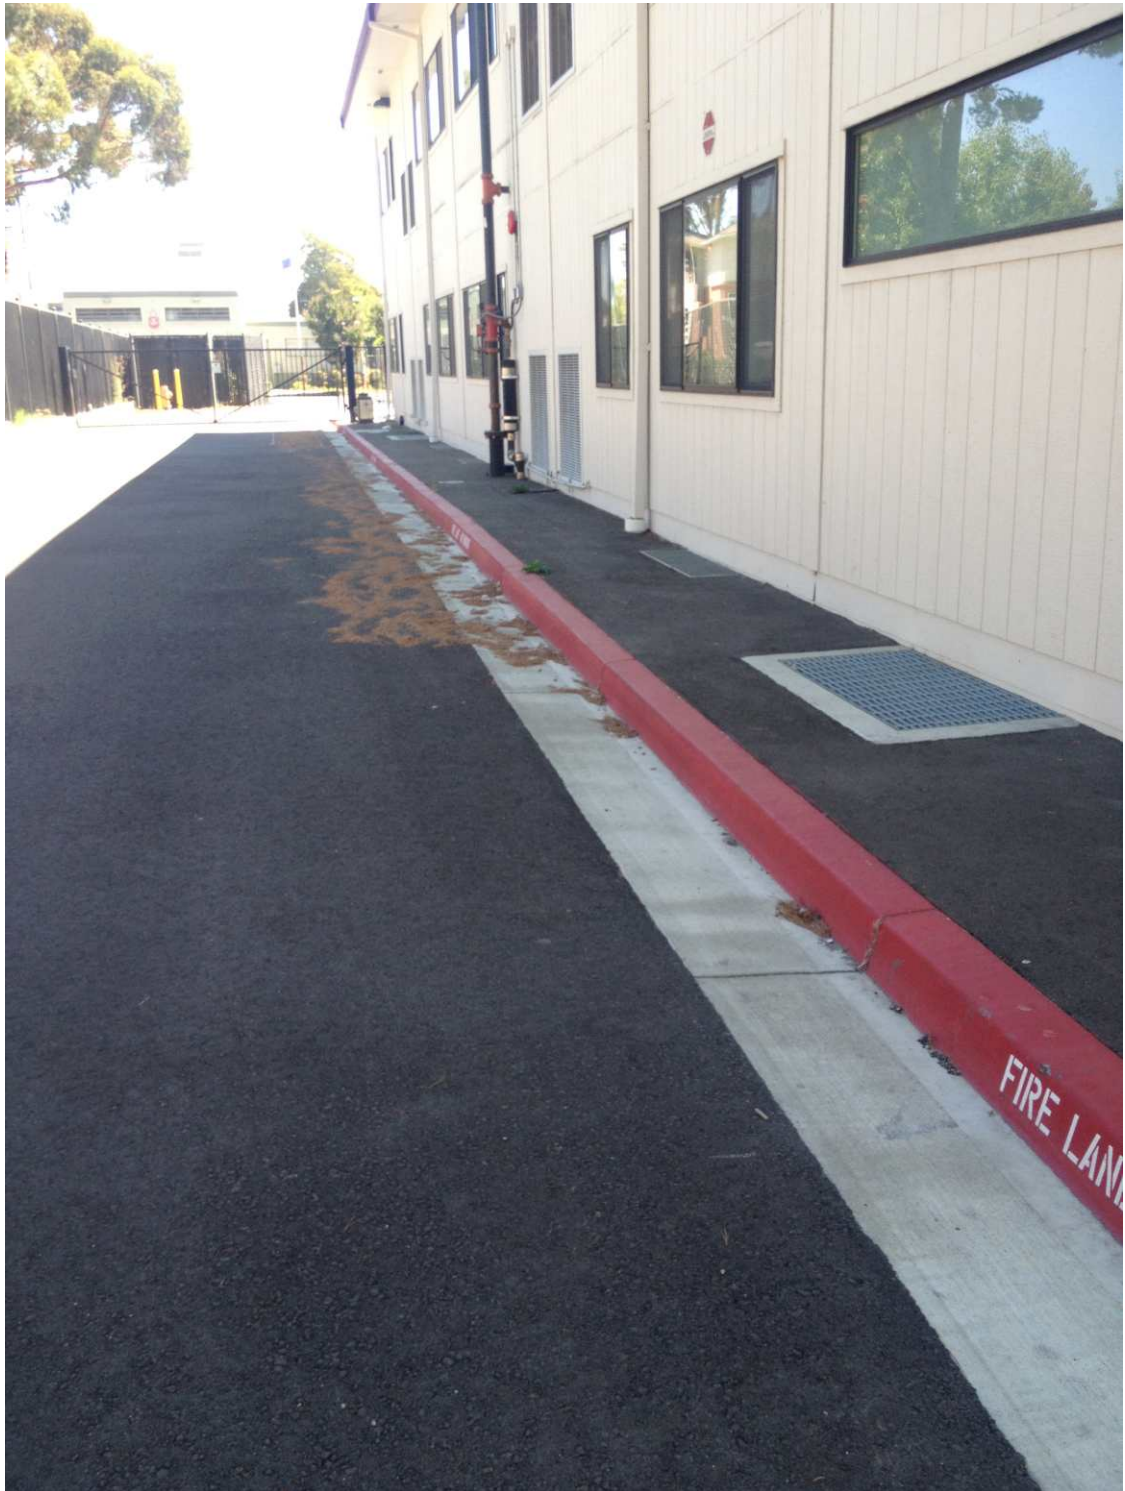
FIGURE
4

Vehicle Traffic Area Adjacent to Classroom on East Side of the Site-
looking towards 66th Avenue

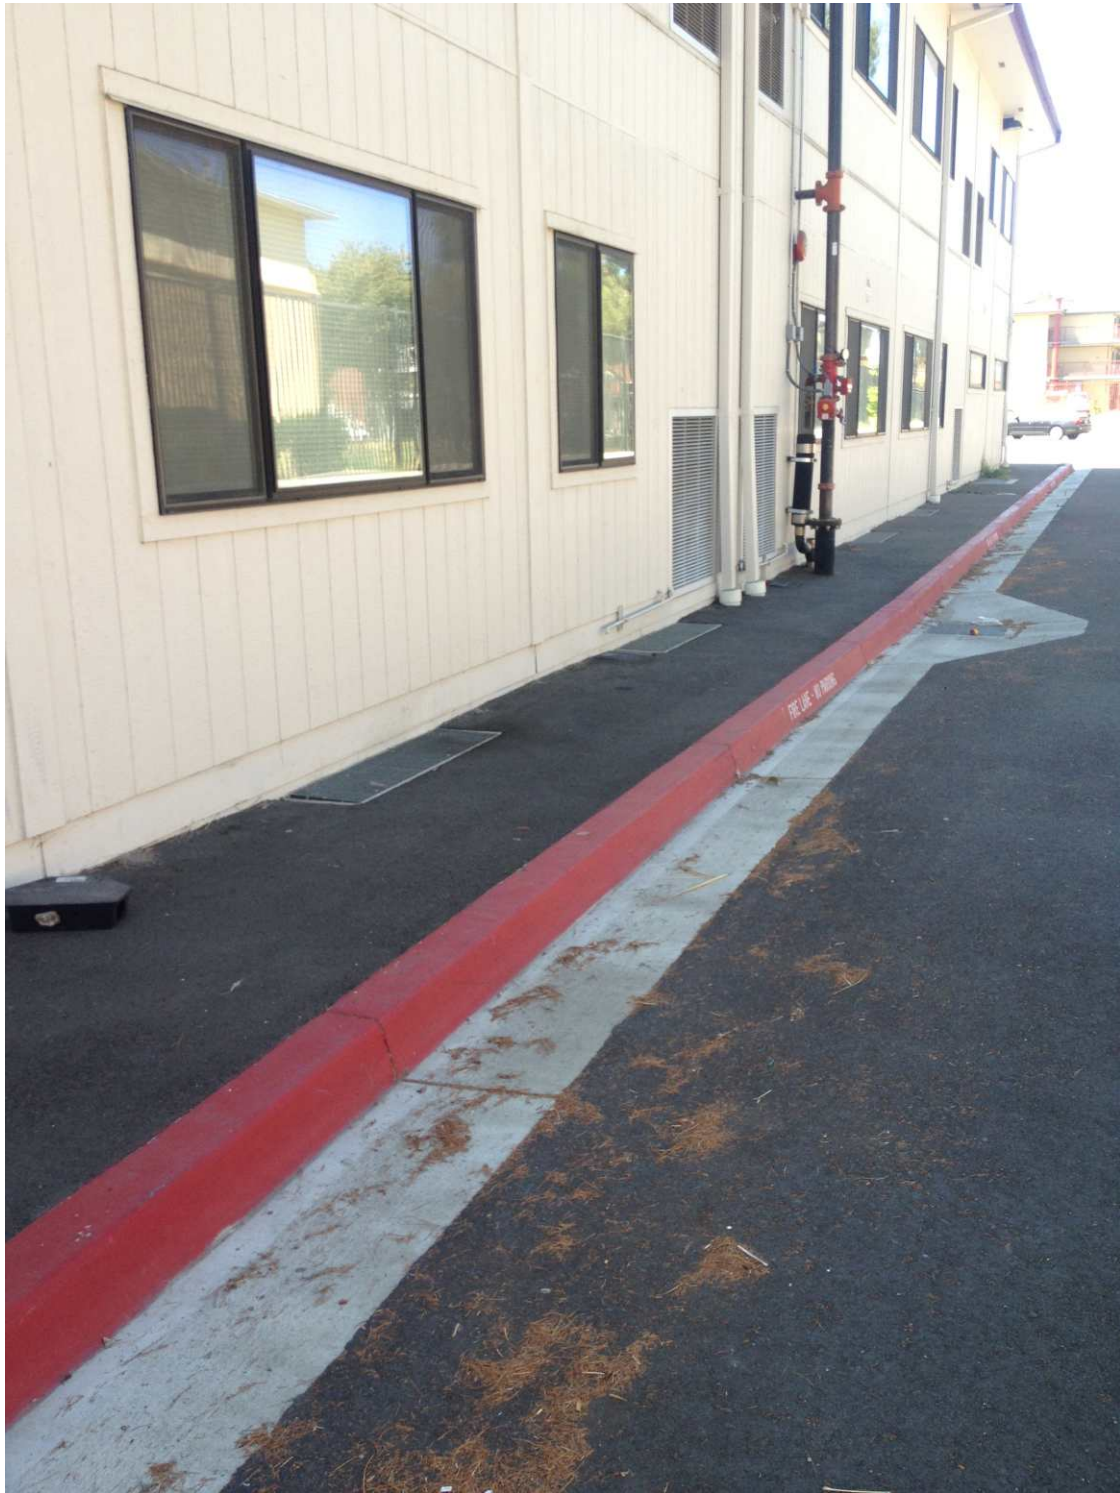
FIGURE
5

Vehicle Traffic Area Adjacent to Classroom on East Side of the Site

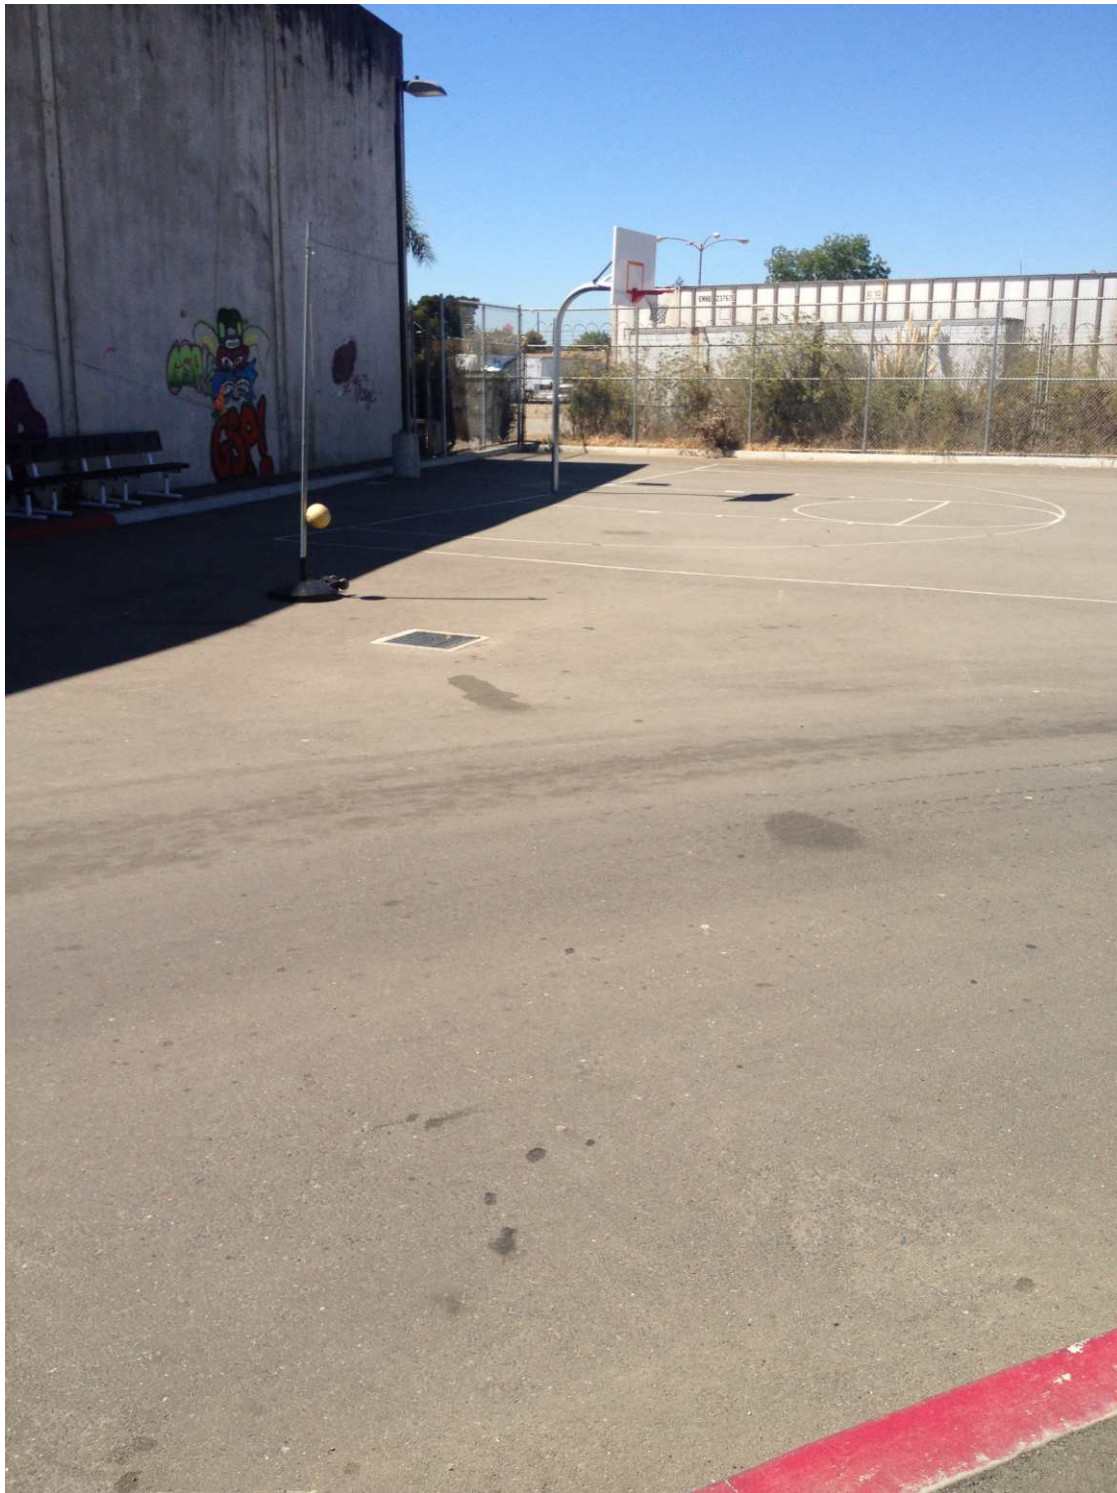
FIGURE
6

Vehicle Traffic Area Near Looking North

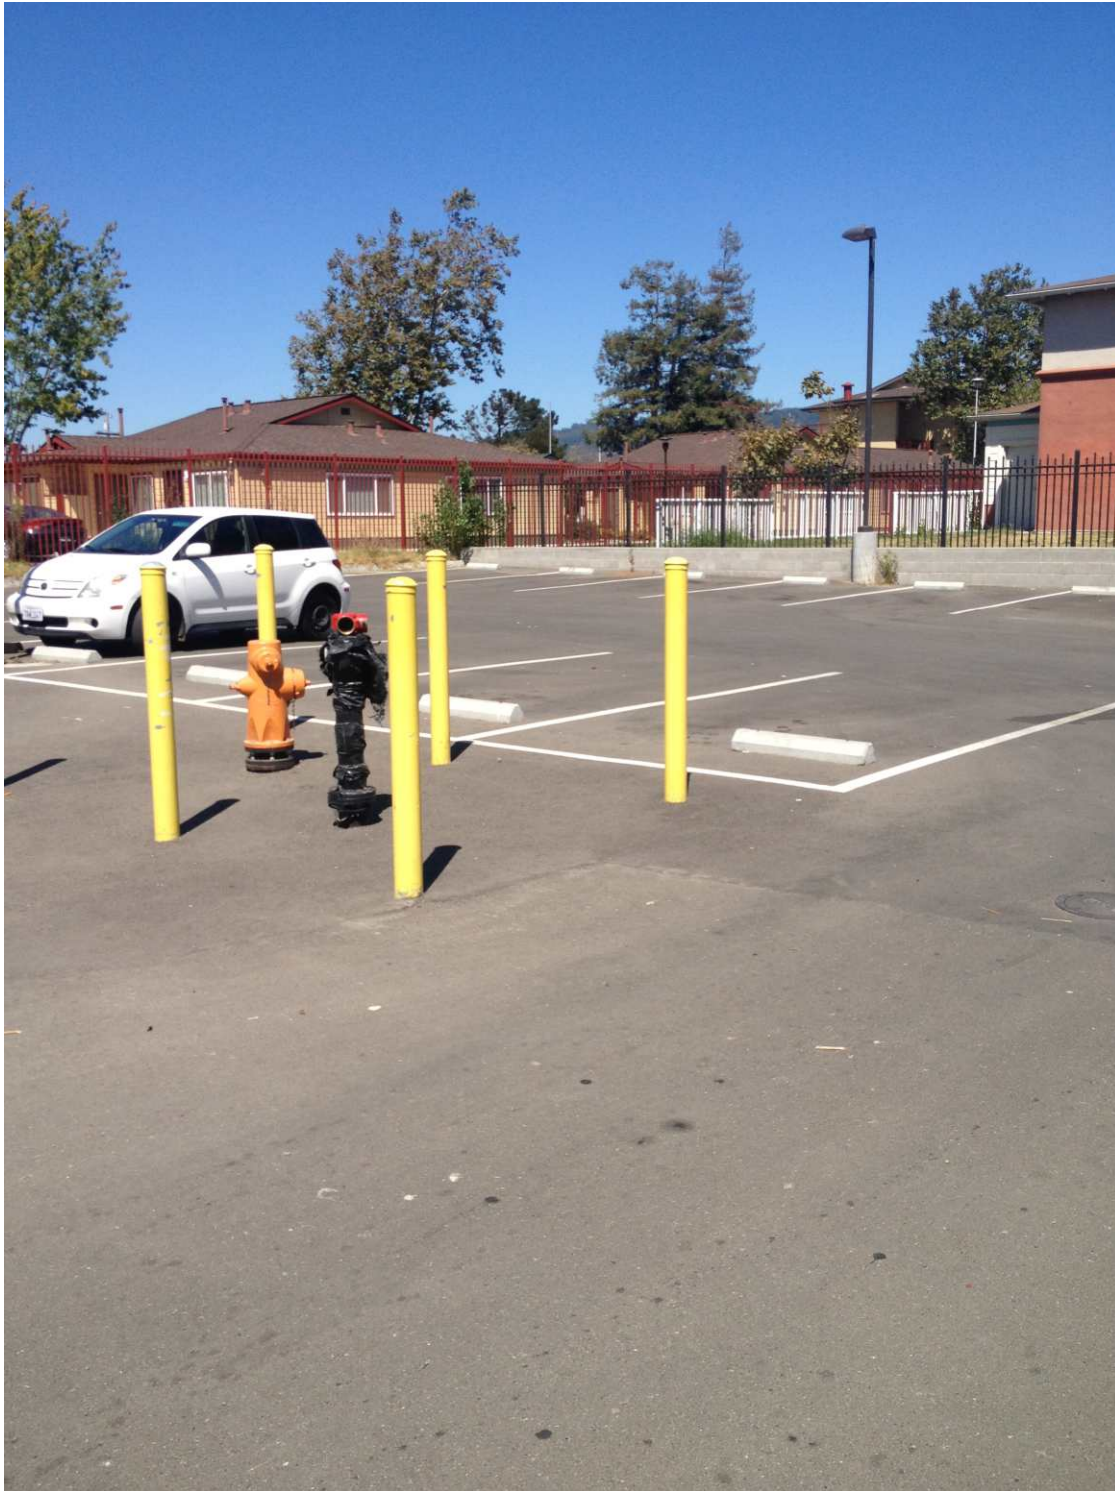
FIGURE
7

Vehicle Traffic Area Near Looking Northeast

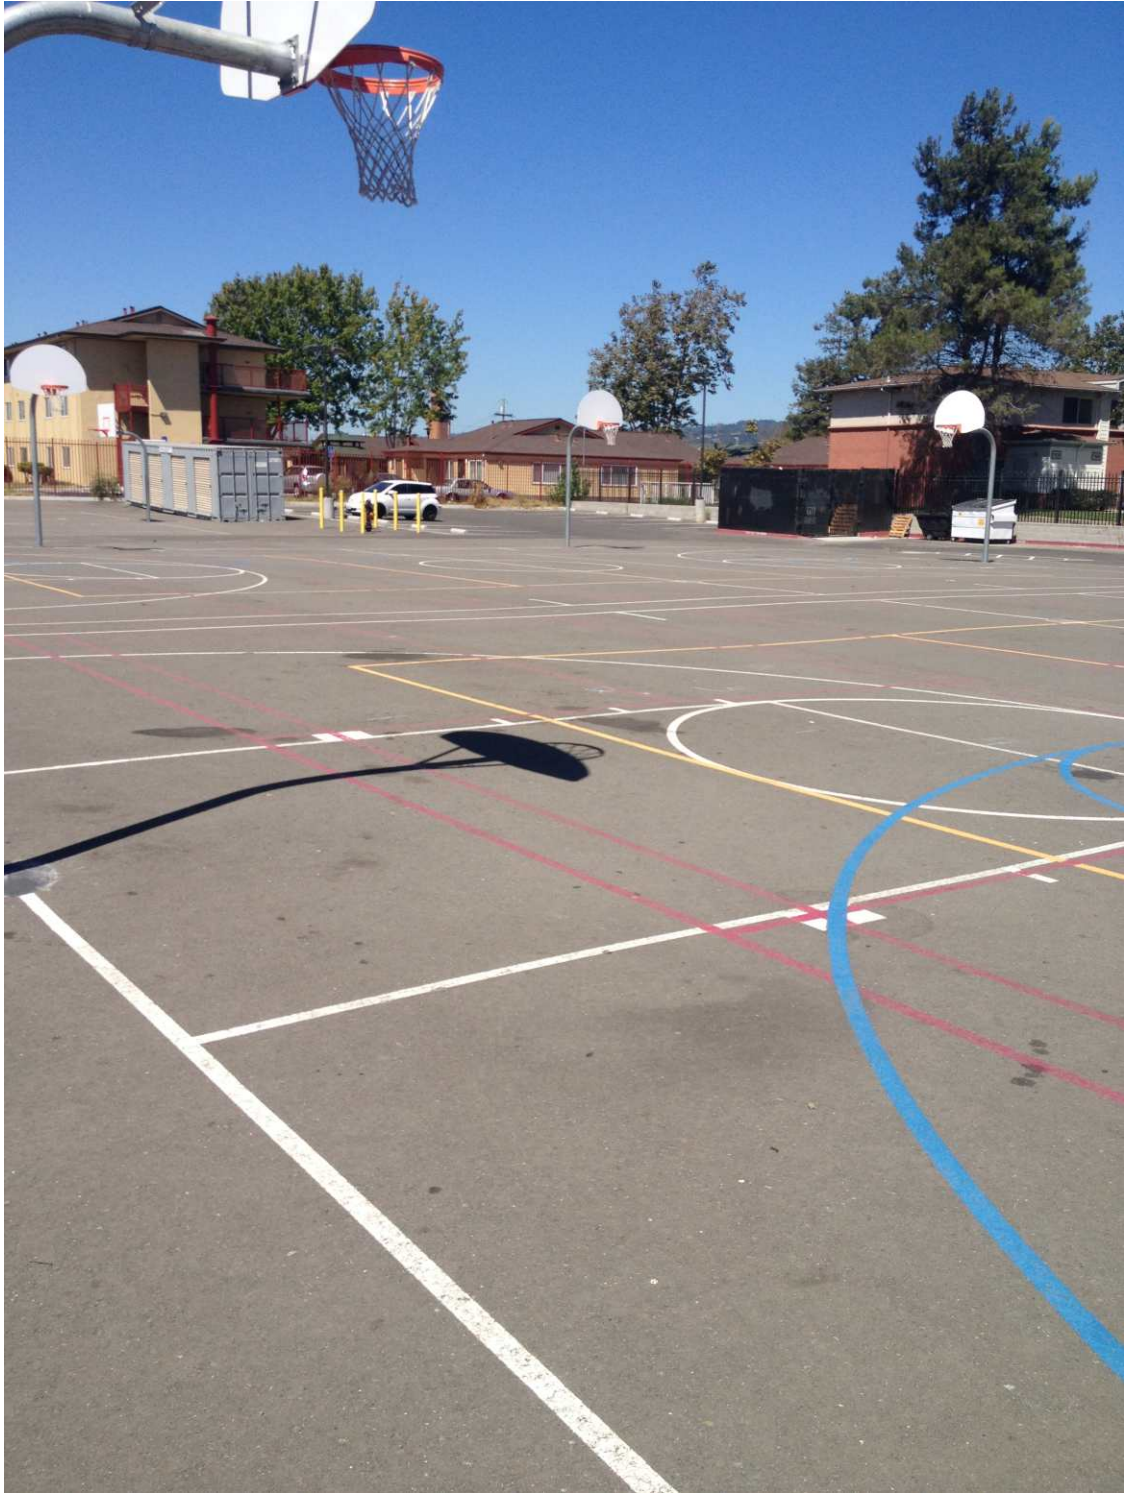
FIGURE
8

Vehicle Traffic Area Near the Rear of the Site

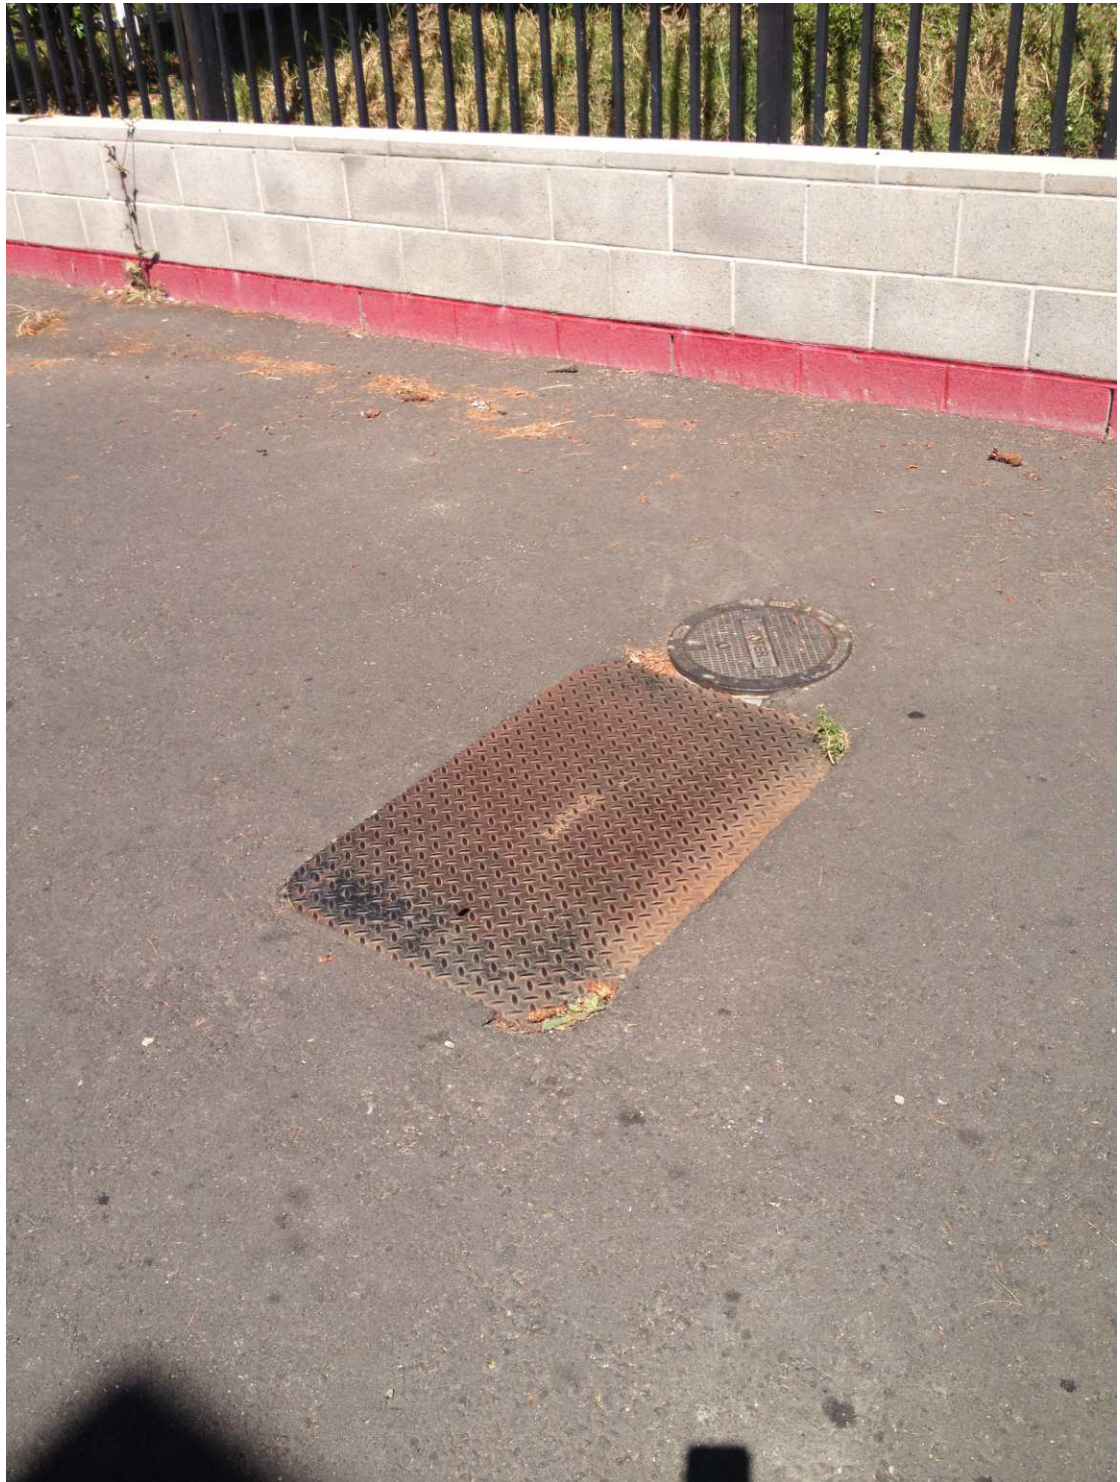
FIGURE
9

Utility Vault in the Vehicle Traffic Area

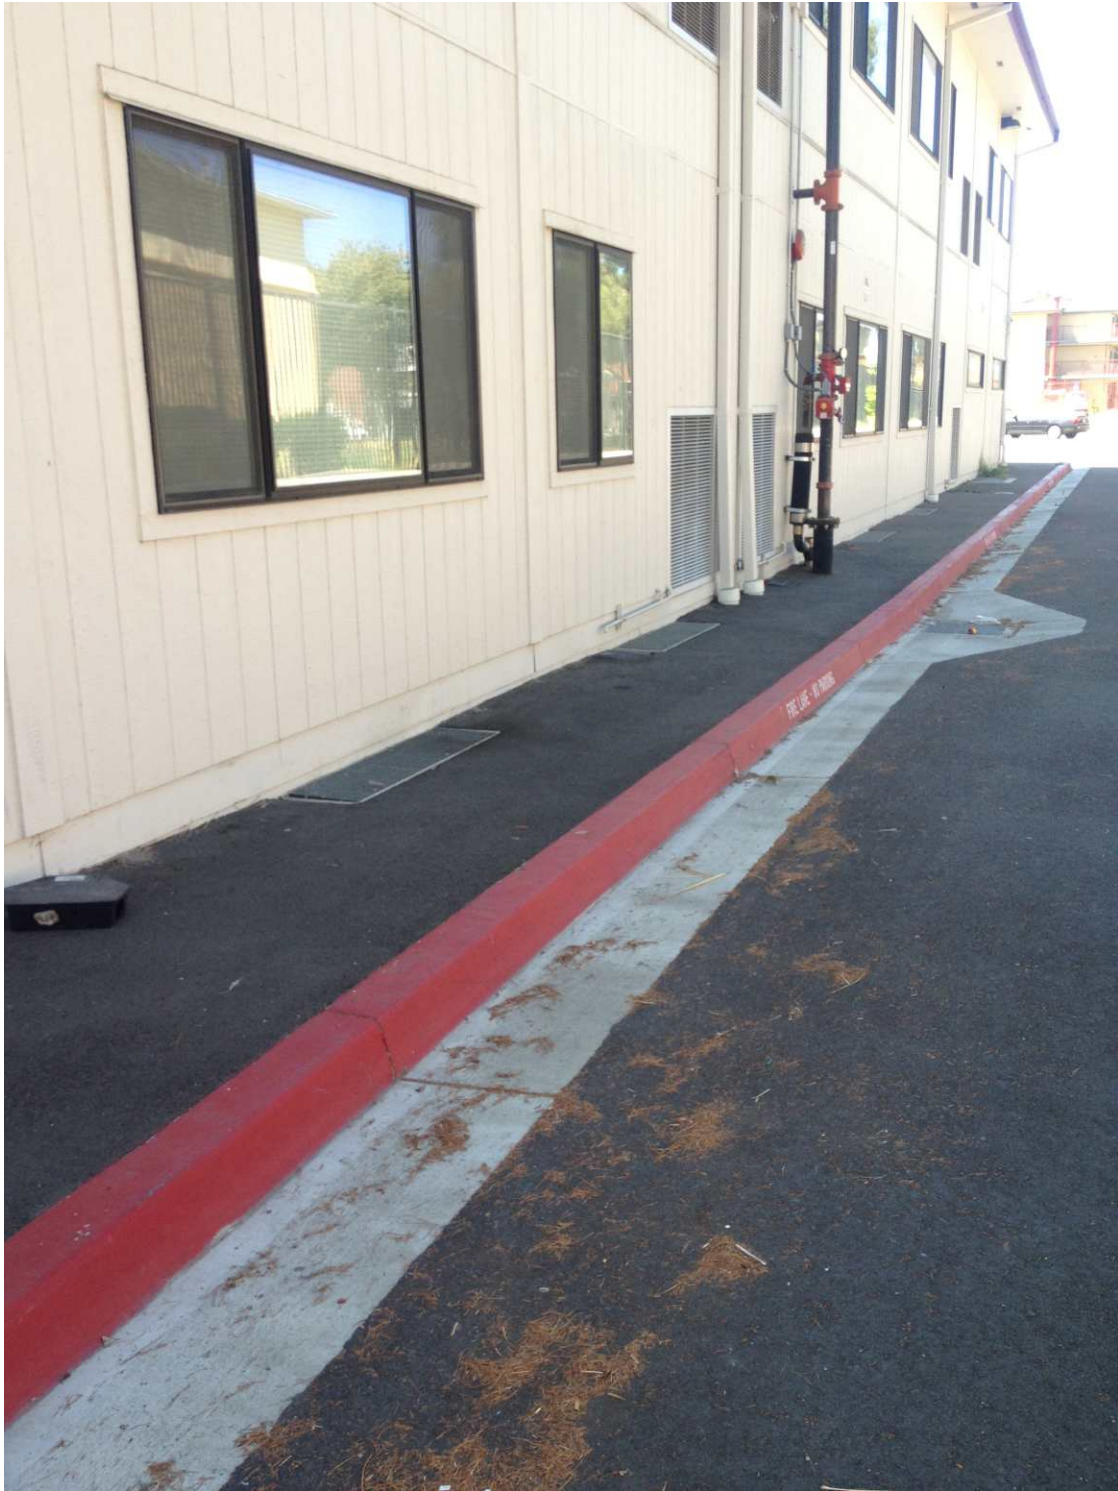
FIGURE
10

Vehicle Traffic Area Adjacent to Classroom on East Side of the Site

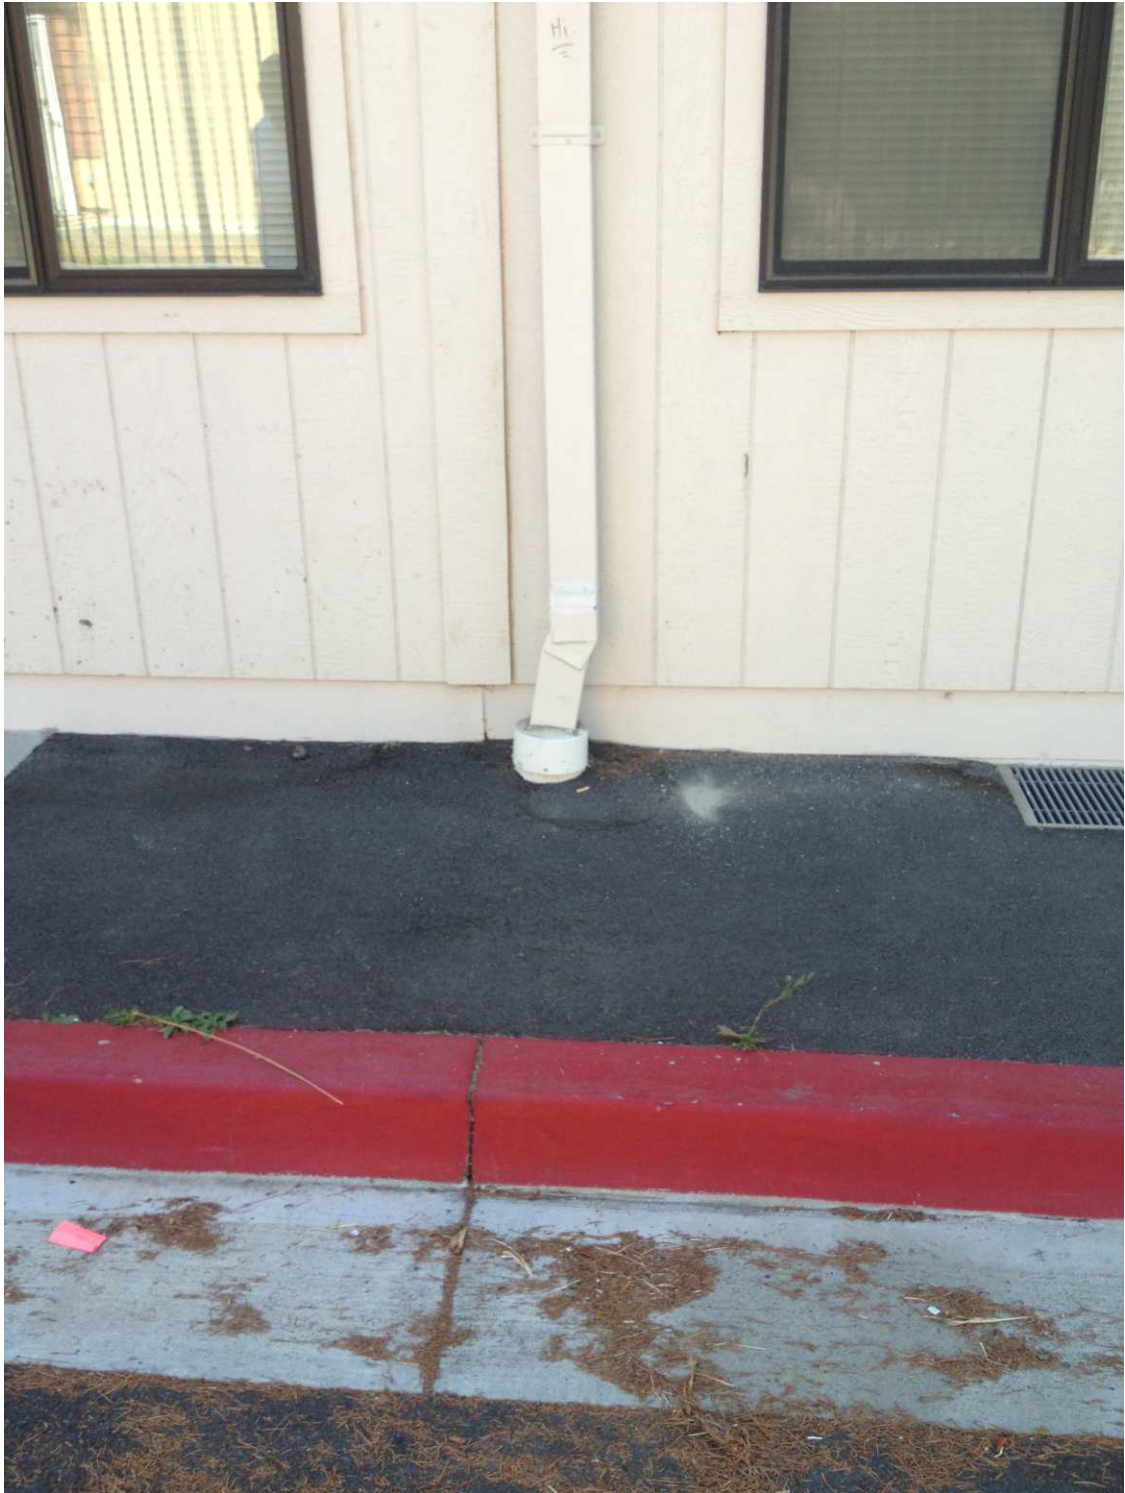
FIGURE
11

hardscaped Area Adjacent to Classroom

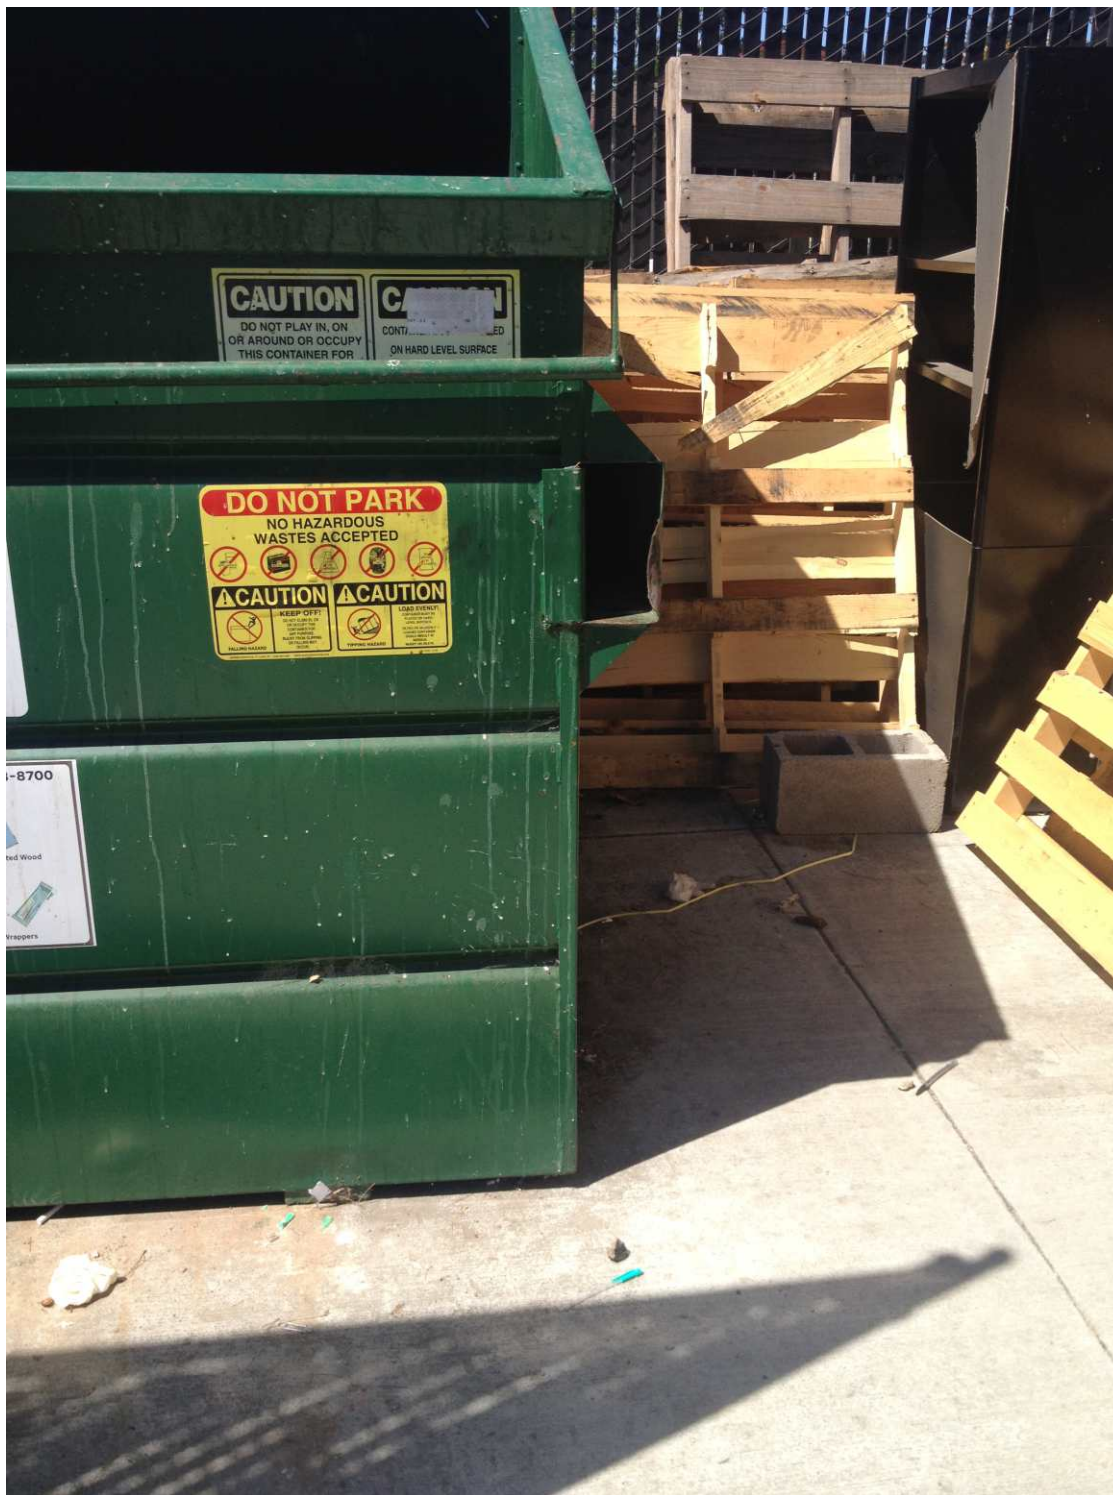
FIGURE
12

Trash Enclosure Area

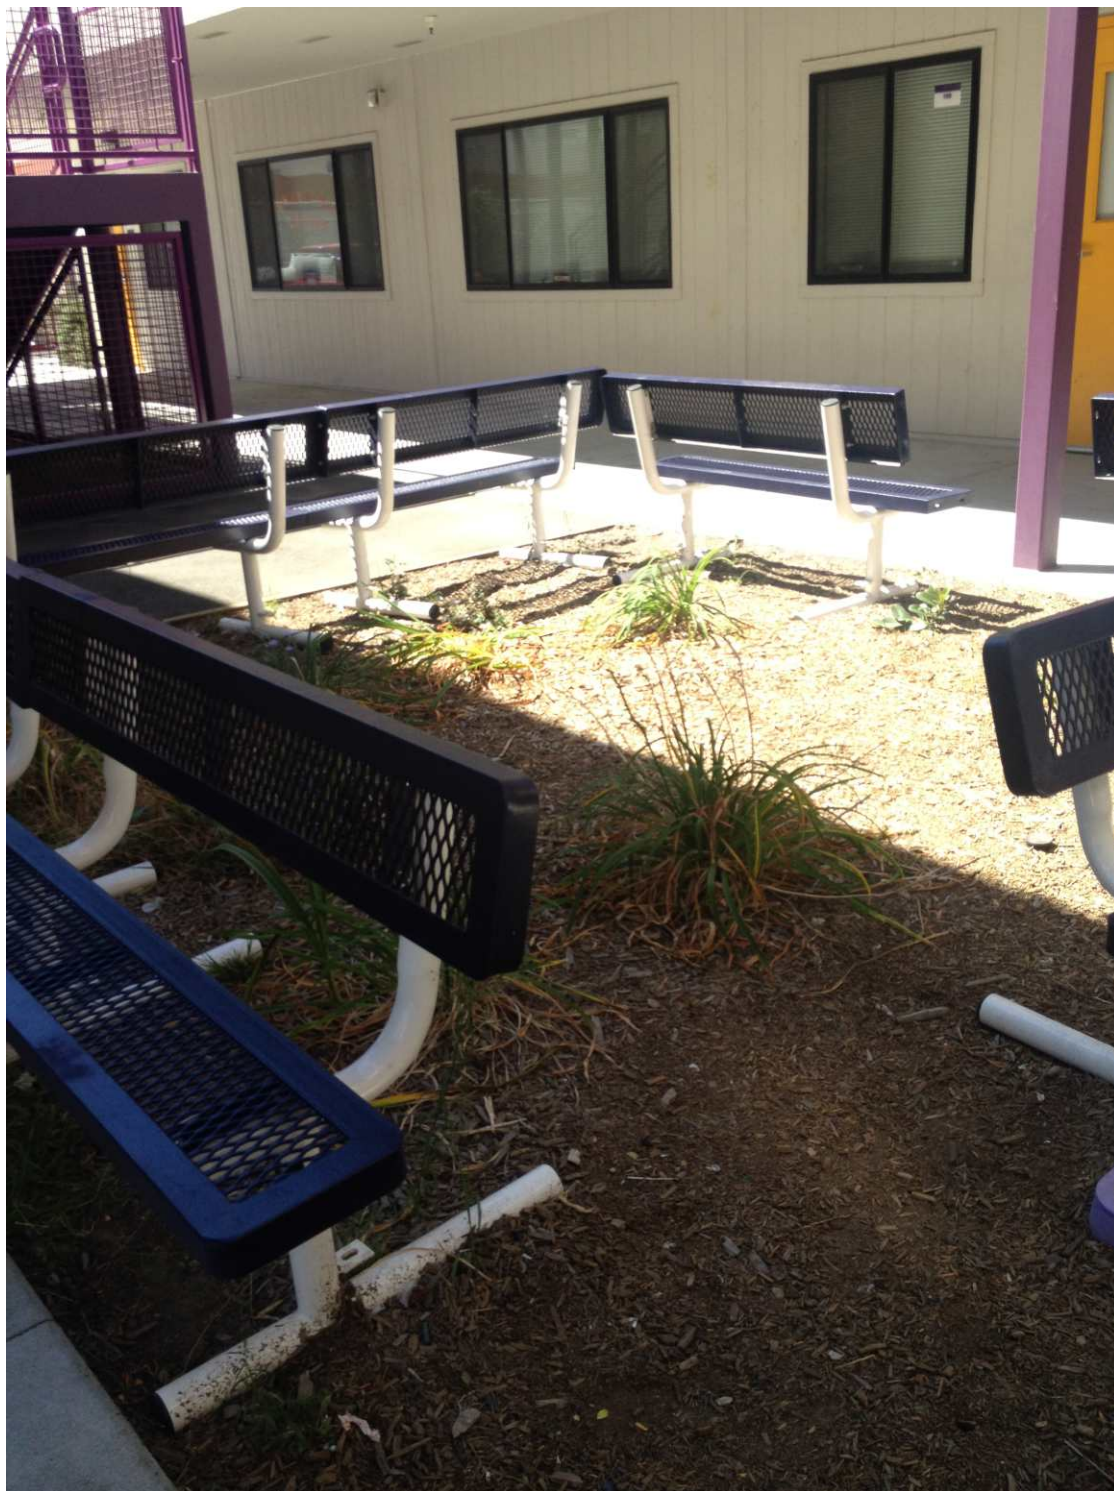
FIGURE
13

Landscaped Area in the Pedestrian Walkway - Courtyard Area
